High Energy Ignitor System & Lighter Controls

Background

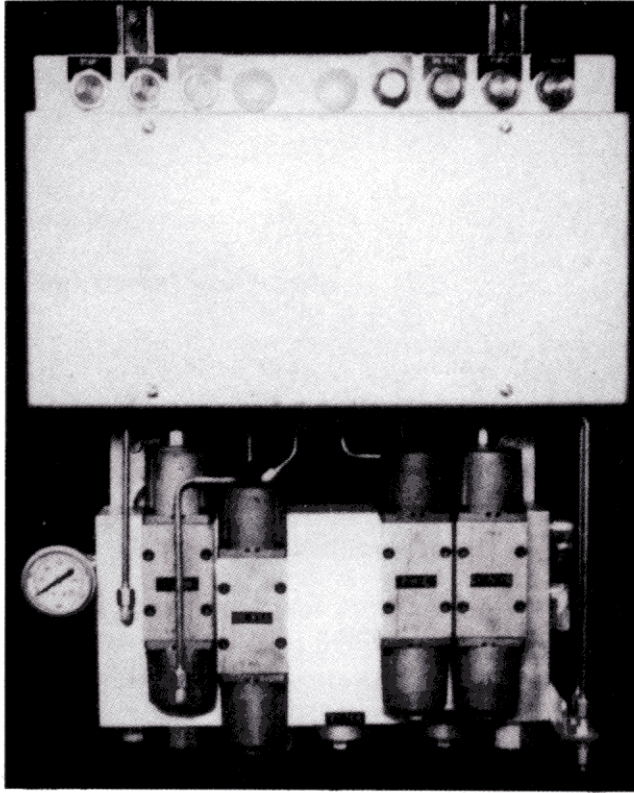
Figure 2 *Electro-pneumatic Lighter Controls*

A. Seal leaks, internal oil leaks, and filter cap leaks on Electro-pneumatic lighter packages.

Cause	Solution
The threads were subject to cross threading.	Extensive reconditioning and overhaul may be required. Earlier designs may make replacement more practical and economical.
