Membraned Wall Corner Tube Failures.

Provide customers information for preventing membraned wall corner tube failures.

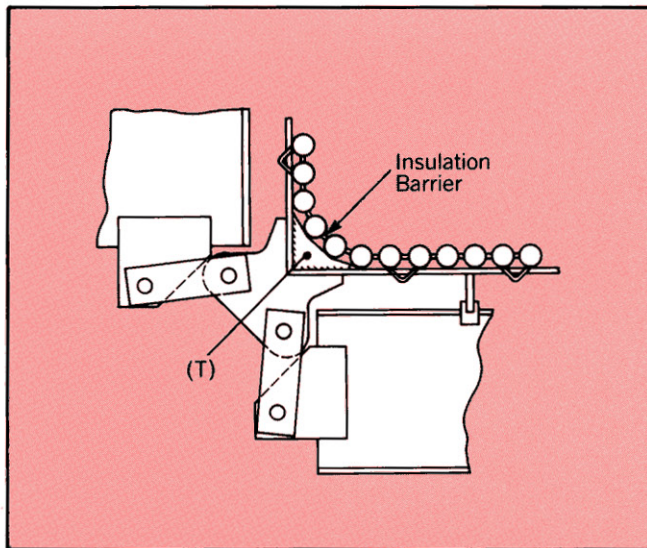
Figure 1 Insulation barrier.

Boilers with membraned furnace walls are subject to corner tube failures at the buckstay elevations. Large drum type boilers, especially RB and large capacity Stirling boilers, using large diameter furnace wall tubing, are affected. The cause of these failures is due to flexing of the furnace corners during large temperature transients. Such transients take place during start-up and shut-down.

1. No solid thermal barrier plates (T), shown on Figure 1. These should be removed and the thermal barrier re-established using insulation packed into the corner cavity.
2. No buckstay standoffs closer than 18" to the corner. Remove all stand offs closer than the 18" limit. See Figure 2.
3. No tie bar pins closer than 18" to the corner. Remove all pins that are closer than the 18" limit. See Figure 2.
4. No weld between tie bars or tie channels closer than 18" to the corner. Weaken all welds by grinding flush with the bar or channel that are closer than the 18" limit. See Figure 3.
5. On boilers utilizing a paddle tie welded to the membraned wall, an Engineering Review is recommended. Figure 4 shows the paddle bar construction.
