Characteristics and Implications of Cracking in Type 304L Composite Floor Tubes in Recovery Boilers

Technical Service Bulletin

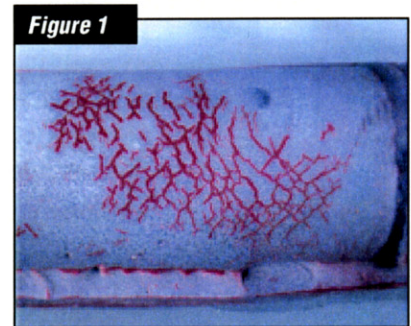
- 1) A crazed pattern of cracking anywhere on the tube surface (Figure 1)
- 2) A circumferential pattern of cracking anywhere on the tube surface (Figure 2)
- 3) A transverse orientation of cracking on the clad surface of the membrane (Figure 3)

If cracks exist in the form of a crazed pattern on the tube (Fig. 1), they will typically not penetrate beyond the Type 304L stainless cladding and into the carbon steel pressure bearing tube. Frequently, the cracks in the stainless cladding will turn and propagate parallel to the stainless steel to carbon steel fusion boundary. If this can be confirmed, the tube may either be replaced or the cracks removed by grinding. If grinding exposes the carbon steel substrate, the surface should be weld-overlaid with Type 309L stainless steel to a thickness comparable to, but no greater than, the original clad layer. All locations where the stainless cladding has cracked sufficiently that spalling

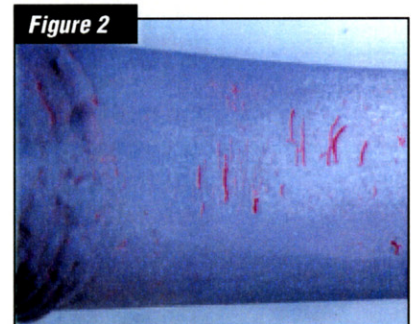
If a circumferential pattern of cracking develops on the tube surface (Fig. 2), there is a likelihood that the cracking has or will penetrate into the carbon steel pressure bearing tube. Tube replacement is the recommended and most reliable remedial measure when circumferential cracks develop and penetrate into the carbon steel pressure bearing tube. Circumferential cracks that do not penetrate beyond the stainless clad layer should be removed by grinding.

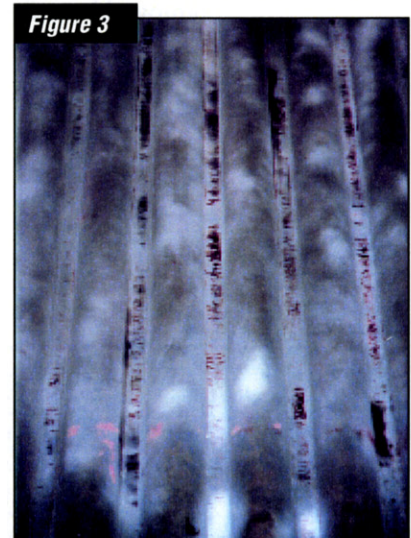
Transverse cracks in the clad surface of the membrane (Fig. 3)

must be removed if the cracks appear to be propagating into the membrane weld and toward the tube. Grinding may be required to determine the depth and extent of cracking. Should grinding of the clad layer of the membrane expose carbon steel, weld-overlay with Type 309L stainless steel is recommended.

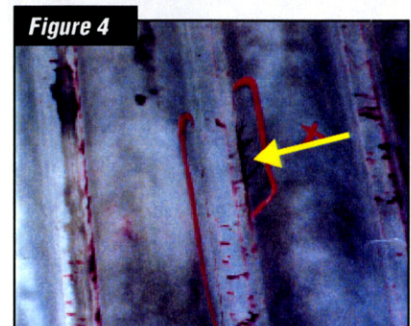
- 4) A longitudinal orientation of cracking along the toe of the membrane to tube weld on either or both the tube or membrane sides of the weld (Figure 4)

If longitudinal cracking develops along the toe of the membrane to tube weld (Fig. 4), there is a likelihood that the cracking has or will penetrate beyond the stainless clad layer of the tube. A floor tube failure has been reported as the result of a longitudinal crack that formed on the tube side of the membrane to tube weld. Tube replacement is the recommended and most reliable remedial measure when longitudinal cracks develop on the tube side of the membrane to tube weld and penetrate into the carbon steel pressure bearing tube. Longitudinal cracks that do not penetrate beyond the

stainless clad layer should be removed by grinding.
