# OVERSPEED IMPELLER TESTING

## FOLLOWING THESE GUIDELINES CAN AVOID TRIPS AND FACILITATE SUCCESSFUL TESTING PER API 617 STANDARDS

BY MARK KUZDZAL AND MARTIN MAIER

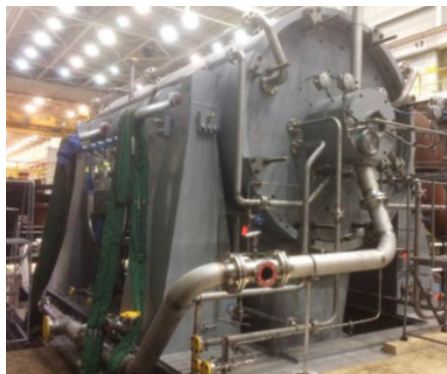
The centrifugal compressor had a radially split, beam-style, five-stage, straight-through design (Figure 1). A steam turbine was used to direct drive the compressor at 5,026 RPM. The impellers were balanced to API 617 8th Edition (ISO 1940/1 G0.67). This was accomplished before each run in the overspeed machine.

Figure 1: Photo of a centrifugal compressor for hydrogen service

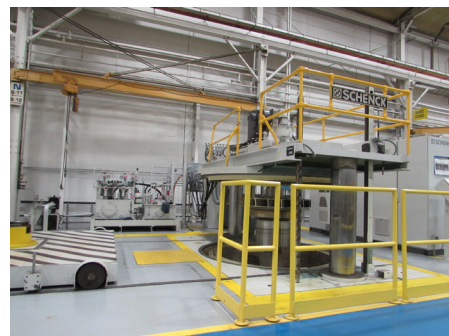
Figure 2: The overspeed test pit. The mandrel assembly is positioned on the cart (far left), which is rolled under the overspeed machine where it is fastened to the spindle. It is lowered into the pit, and a vacuum pump evacuates the chamber to minimize the power required to drive the impeller and heat generation associated with windage.

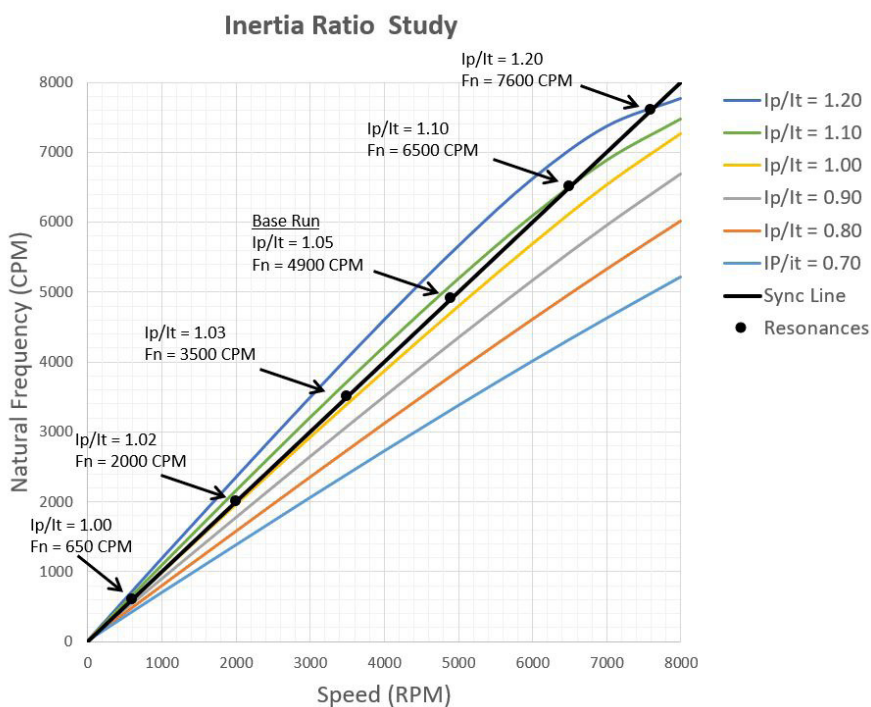
**Figure 3. Damped Eigenvalue Plot for mandrel assemblies showing curves for  $I_p/I_t$  inertia ratios ranging from 1.20 - 0.70. The resonance frequencies (intersections with the synchronous speed line) change rapidly as the inertia ratio is reduced from 1.10 to 1.0, so this region should be avoided. For inertia ratios below 1.0, the resonance frequency is in the 100 cycles per minute (CPM) to 300 CPM range.**

An inertia study was performed. The separation distance between the disks was varied to change the transverse inertia and associated  $I_p/I_t$  ratio. It is evident that the natural frequency for inertia ratios close to 1.0 is sensitive to small variations in modeling, boundary conditions, and assumptions. For this reason, operation at inertia ratios between 1.0 - 0.95 should also be avoided.

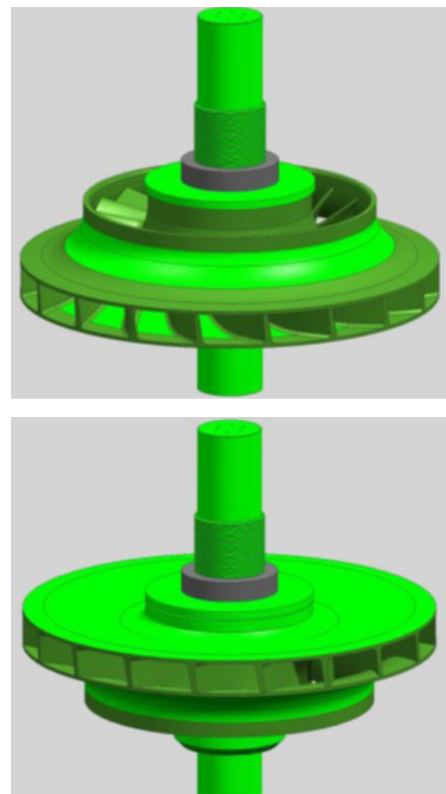
**Figure 4. Impeller shroud facing up (left) and impeller shroud facing down (right).**

Flywheel testing ultimately proved to be unsuccessful due to problems associated with repeated vibration during start-up and shutdown. However, during testing, it was noted by shop personnel that, in some instances, impellers ran better when they were mounted with the shroud facing downward. As the newly designed mandrel was not yet available for testing, this suggestion was noted and tested. The flywheel was then removed, and the impeller mounted on the existing mandrel with the shroud facing downward (Figure 4).

With the impeller shroud facing down, the rotor assembly successfully reached overspeed. One factor that may account for this result is the  $I_p/I_t$  inertia ratio. It increased from 1.05 to 1.13 after flipping the impeller. Another factor is the residual unbalance. It may have shifted closer to the mandrel's center of gravity. Rotor dynamic calculations indicate that if the unbalance shifts by a little as 1.0 inch (25.4 mm), such that it coincides with the mode's pivot point, the system response is virtually eliminated.
